Australian Building Inspection Services Pty. Ltd.

New Construction Handover Report

Property Inspected: Lot 99, 22 New Street NEWDIV QLD 4777

ID: I99999

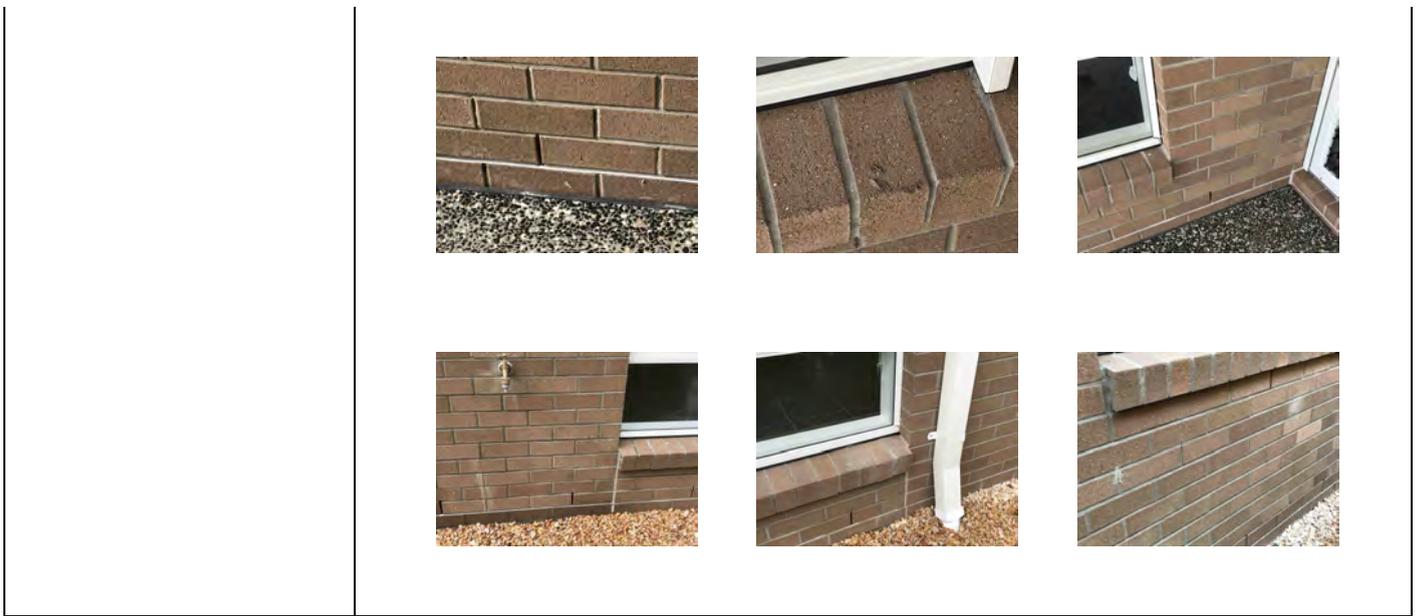
Exterior Walls Defect	
Which Wall	Exterior wall to the main building
Location	In general
Element	Brickwork
Defect	Requires builders final clean
Defect Category	Defect in Secondary or Finishing Element
Severity	Minor
Extent	Widespread
Recommendation	A further investigation by a Builder is recommended to determine the extent of work required and associated costs.
Photos

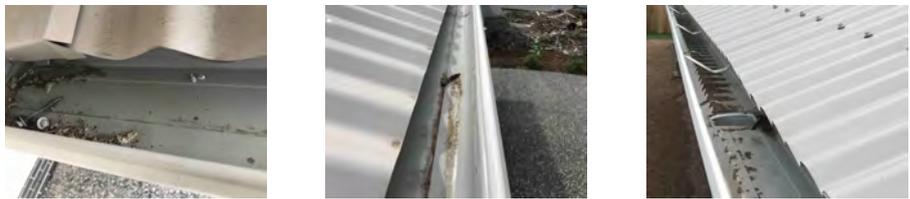
Rainwater Good Defect	
Which Building	Main Building
Location	In general
Element	Eaves Gutter Brackets
Defect	Remove rubbish from gutters
Defect Category	Defect in Secondary or Finishing Element
Severity	Minor
Extent	The extent was undetermined
Recommendation	A further investigation by a Builder is recommended to determine the extent of work required and associated costs.
Photos

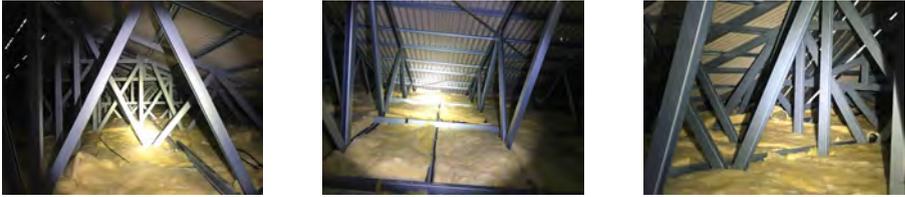
Type of Roof Space Inspection	Limited inspection made from the manhole the inspector did not enter roof void
Photos

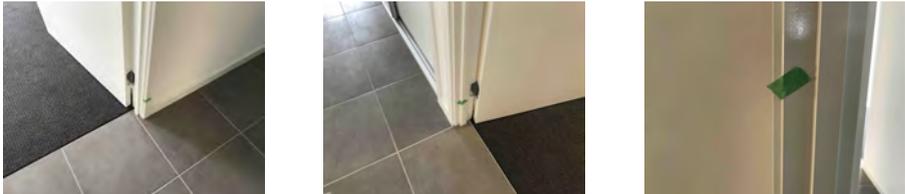
Interior Walls Defect	
Location	In general
Element	Paintwork Wall plasterwork Timber framed wall Wall finish
Defect	Dents, Marks, Scratches and the like Minor paintwork imperfections
Defect Category	Defect in Secondary or Finishing Element
Severity	Minor
Extent	The extent was undetermined
Recommendation	A further investigation by a Builder is recommended to determine the extent of work required and associated costs.
Photos

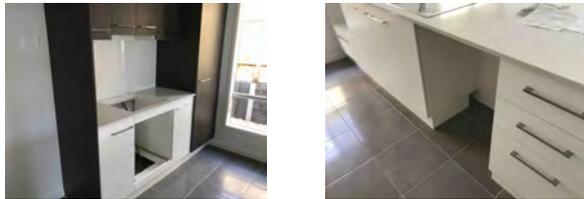
Built-in Fittings Defect	
Which Builtin	Built-in-fittings
Location	Kitchen

Element	Cook Top Oven Range hood Dishwasher
Defect	Missing
Defect Category	Defect in Secondary or Finishing Element
Severity	Moderate - Repairs may involve significant expenditure
Extent	Localised
Recommendation	A further investigation by a Builder is recommended to determine the extent of work required and associated costs.
Photos
